# Stopper “Pop-Up” and the Effects on Container Closure of Sterile Vials

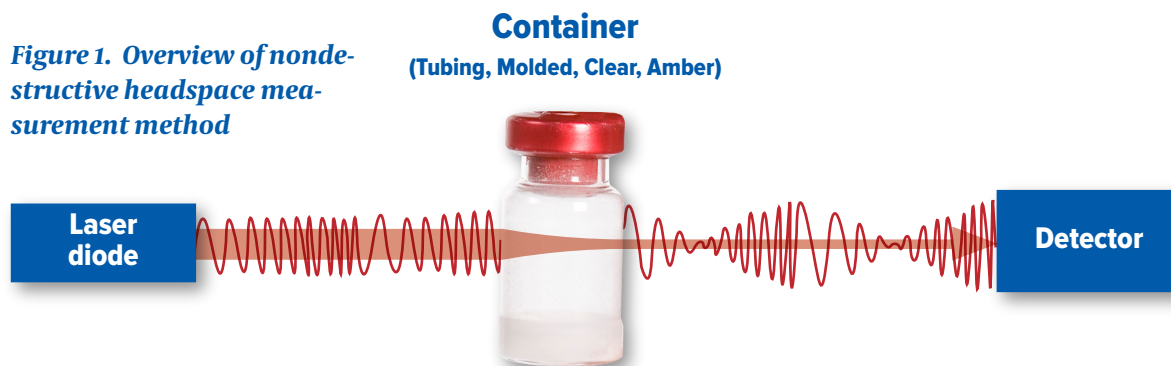
Systems for nondestructive headspace analysis using laser absorption spectroscopy are configured as shown in Figure 1. Laser light passes through the headspace of a vial and the laser wavelength is tuned to match the absorption wavelength of oxygen at 760 nanometers or moisture at 1400 nanometers. Oxygen con-

centration is proportional to the amplitude of the laser absorption signal and total gas pressure is proportional to the width of the laser absorption signal. Systems are calibrated using NIST traceable standards with known pressure and oxygen concentration.

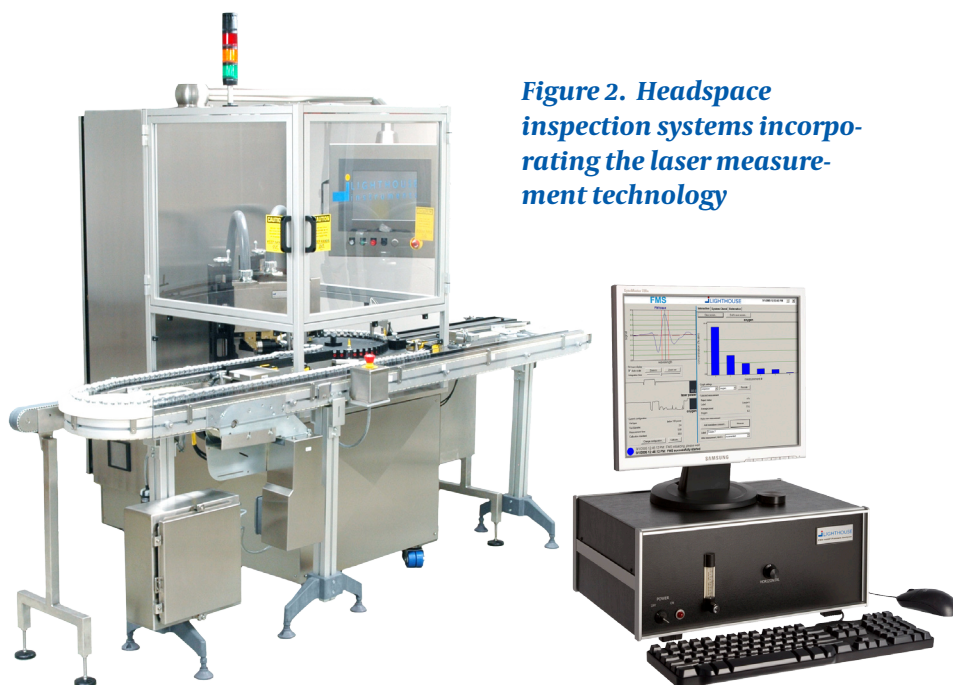
**Figure 2. Headspace inspection systems incorporating the laser measurement technology**

In the case studies described below non-destructive headspace gas analysis systems from LIGHTHOUSE were used to monitor container closure integrity for commercial batches of lyophilized product. Systems, shown in Figure 2, can be configured for manual operation or in-line automated operation. Manually loaded systems are useful for conducting investiga-

tions or in-process monitoring of small (<5000) batches of containers. Automated systems are configured for 100% inspection applications when batch sizes are large.
